Pukekohe Hospital Plantroom - Concept Strengthening

Beca has been engaged to complete strengthening works to the Pukekohe Hospital Plantroom at Pukekohe, Auckland. The purpose of this letter is to provide a summary of our work to date and direction for next steps going forward.

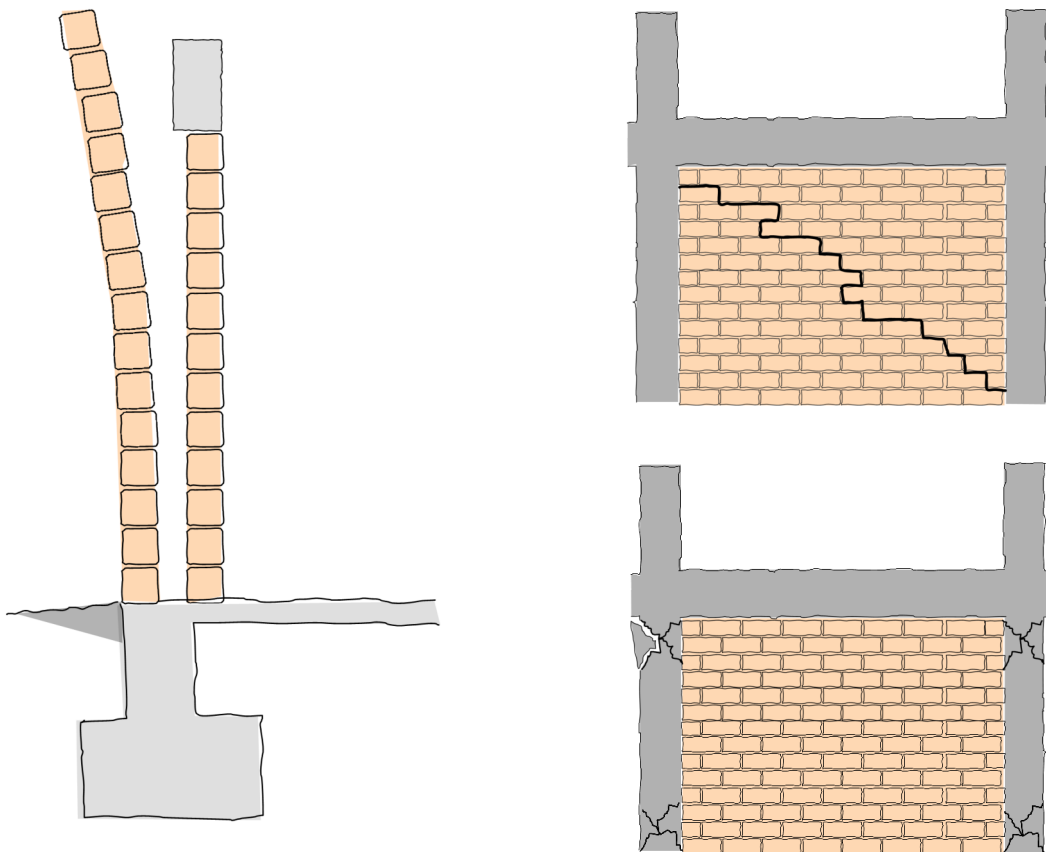
The exterior URM veneer is critical with a score of 20%NBS (IL3). There is no evidence of restraint to the top of these veneers, and the wall is thus required to cantilever from ground floor level.

Figure 1: Clockwise - out-of-plane failure of the external veneer, direct tension failure of the URM infill, shear failure of the columns from short column effects

The column shear failure is caused by the development of compression struts in the brick infill. These struts are eccentric to the frame intersection points, forming large shear demands in the columns or beams. As the smaller infills fail progressively in compression, the load is distributed to the larger walls which fail the columns. The column failure in shear is non-ductile and deemed a loss of gravity support to the roof structure.
